Microsoft XBOX 360 Quick Charge Kit Bad Capacitor Replacement

Failed Xbox Quick Charge Kit not continuing to charge, or charging at all. LED off or intermittent when unplugging & re-plugging charger from power source.

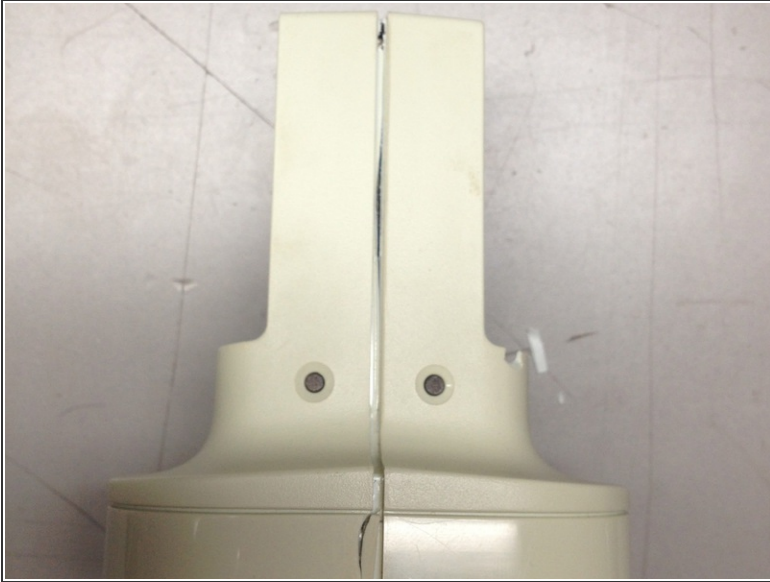
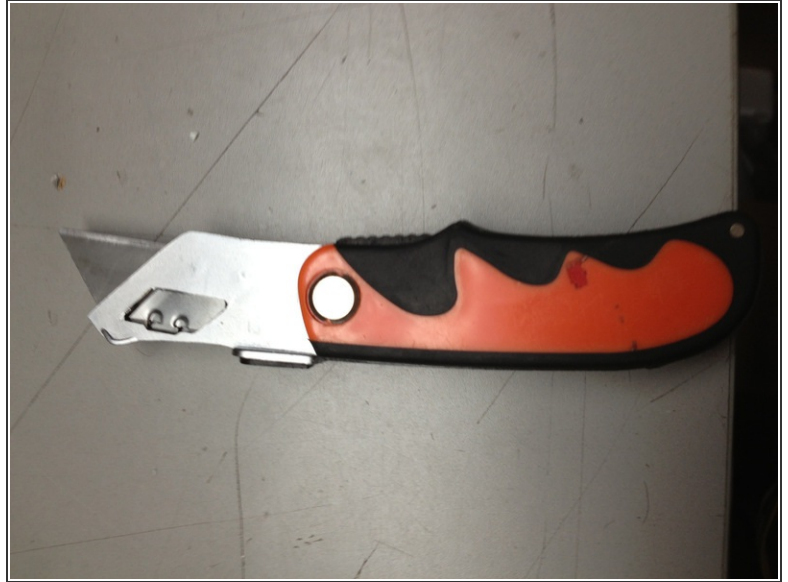
Step 1 — Bad Capacitor causing charge to fail

- Unit is glued together, making disassembly somewhat difficult. Using a utility knife, repeatedly score the plastic, top to bottom and all the way around, in the seam on the face, rear and bottom of the charger. The knife will begin to penetrate the charger.

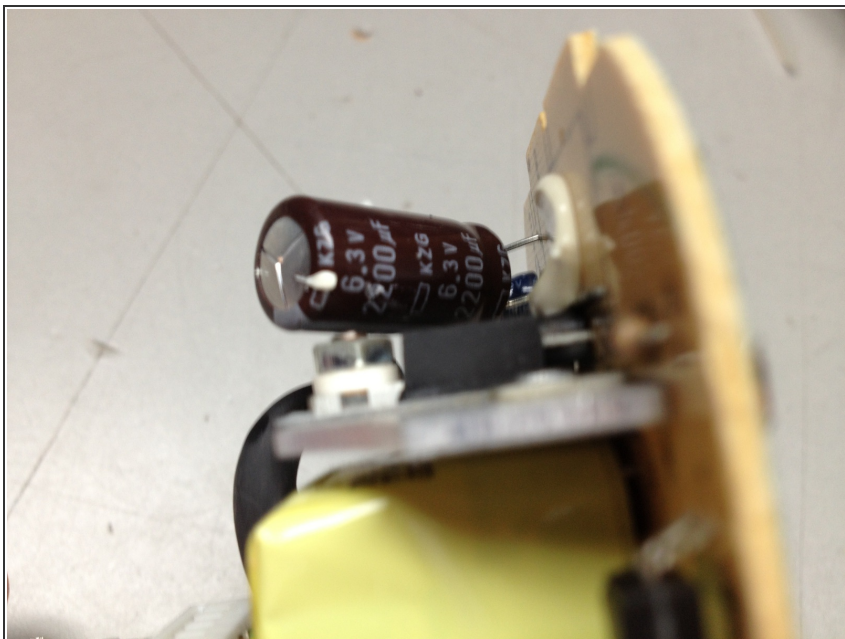
Step 3

- Note the bulging top of the failed capacitor. It's a 2200uf 6.3V available at any local TV repair shop.
- De-solder it from the board noting the polarity. The side with the grey line is the negative that faces the heat sink.
